# Industrial Electronics 1200B: restoration and a 405-line television

Project405 · October 2026

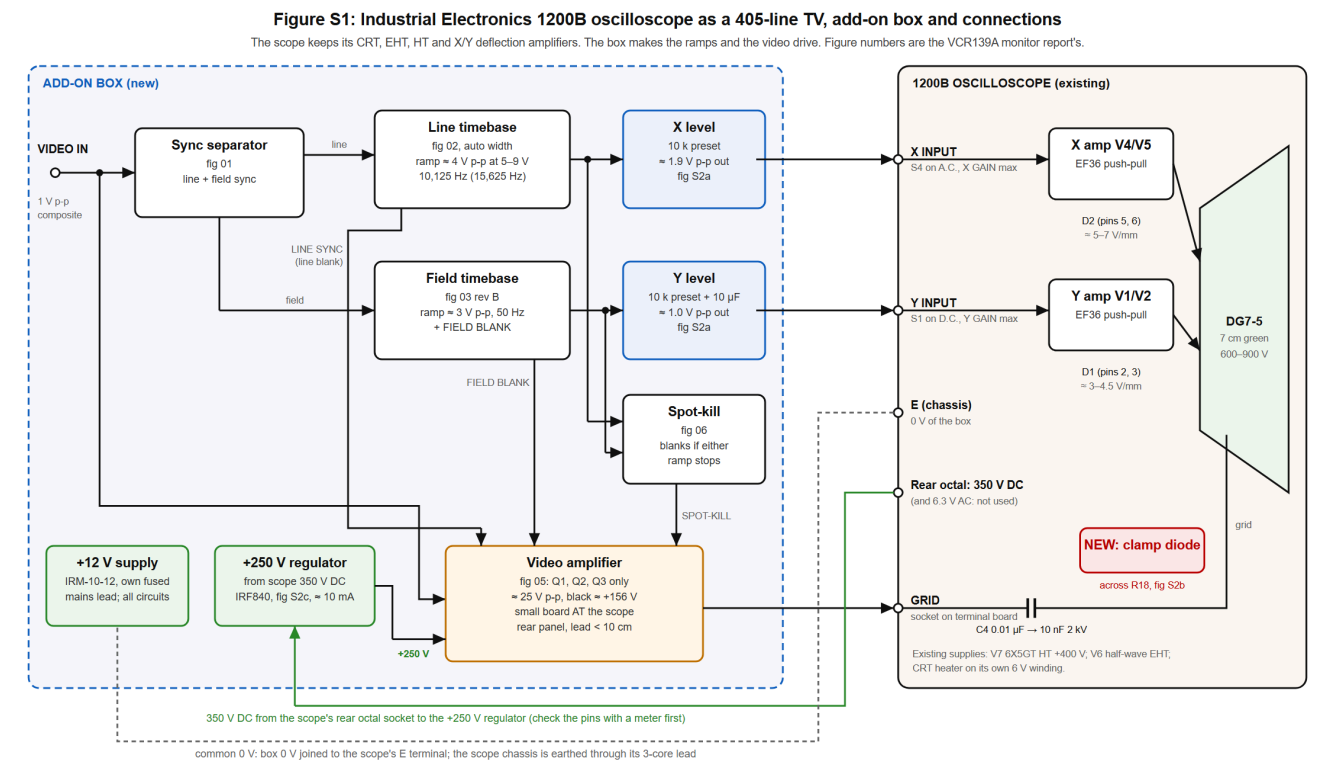
Picture 48 × 36 mm (4:3) inside the 7 cm screen: X needs ≈ 230–340 V p-p between the D2 plates, Y = 110–160 V p-p on D1 (EHT 600–900 V). Scope sensitivities ±20 %; set the presets on the bench. Both scope gain pots at maximum; the manual warns they are not frequency-compensated and lose HF part-way round. The internal gas-triode time base is switched out (S4 on A.C.).  
**Untested design. Recap and check the 1950s scope (report §4) before connecting anything.**

Most of a 405-line picture monitor is already inside the 1200B: a tube, an EHT supply, and two DC-coupled deflection amplifiers. What it lacks is something to make a raster and put the picture on the grid. Rather than rebuild the scope, I'm adding an **external box** that does that job and plugs into the scope's existing inputs.

The box reuses modules from my VCR139A television monitor:

| Module | Job |
| Sync separator (LM1881, Addendum A) | Takes composite video and gives line and field sync |
| Line timebase | A 10,125 Hz ramp, fed to the scope's <b>X</b> input |
| Field timebase | A 50 Hz ramp, fed to the scope's <b>Y</b> input (DC-coupled) |
| Video amplifier | Drives the CRT grid through the scope's GRID socket, with line and field blanking |
| Spot-kill | Blanks the beam if either ramp fails, so a still spot can't burn the screen |
